CARBON FIBER COUNTERSUNK STAPLE

THE BEST FOUNDATION CRACK REPAIR AND STABILIZATION SYSTEM

CARBON FIBER COUNTERSUNK STAPLES

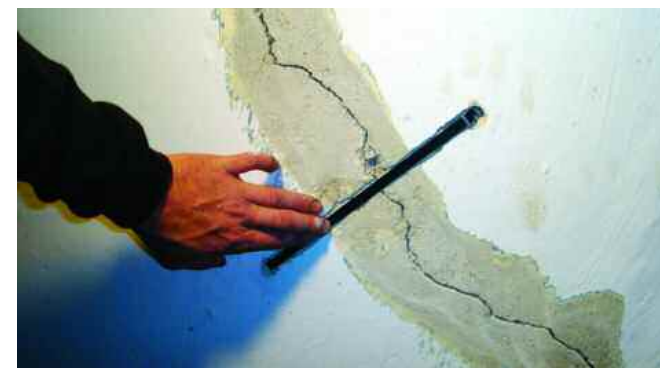
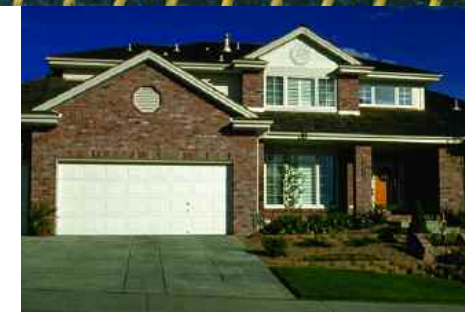
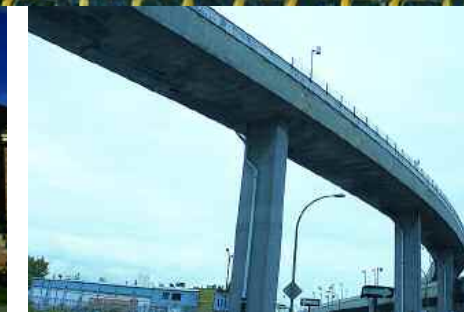
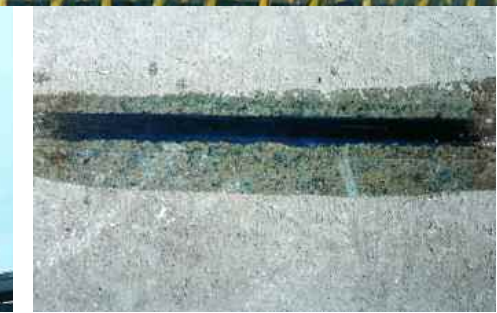
6 directions of wall movement

Closing thermal changes

Opening thermal changes

Uneven loading & settling of footing

Soil shrinkage

Soil pressure

The 6th direction of movements is a combination of all the other 5 wall movements.

Understanding this Fortress Stabilization has researched, developed and patented a unique carbon fiber countersunk staple that will help stabilize the wall in all 6 directions of movement.

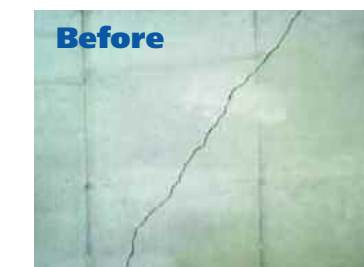
Before

Pictures to the left is a typical foundation crack. Below is after Fortress Stabilization carbon fiber countersunk staples are installed and the wall is ready to be painted.

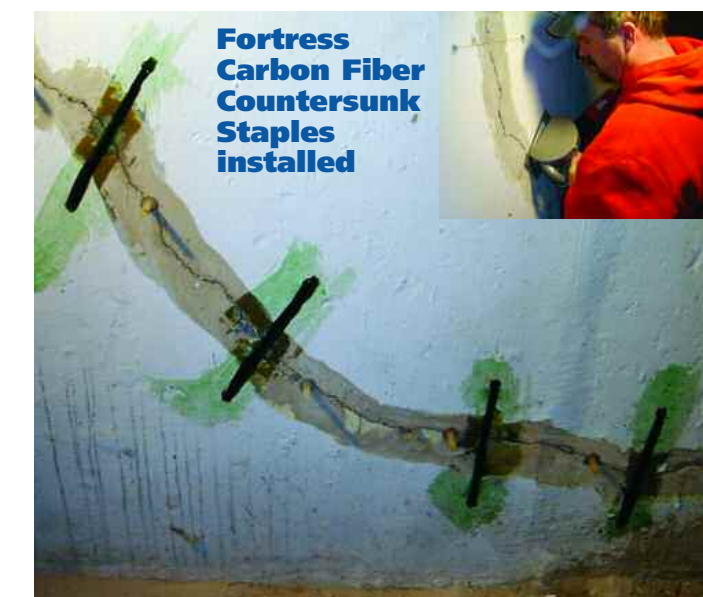
Fortress Carbon Fiber Countersunk Staples installed
